INSURANCE SURVEY REPORT

'CHARLOTTE ROSE'

SURVEYED AT PORTLAND MARINA, DORSET
3RD AUGUST 2022.

SWS
Marine Surveys

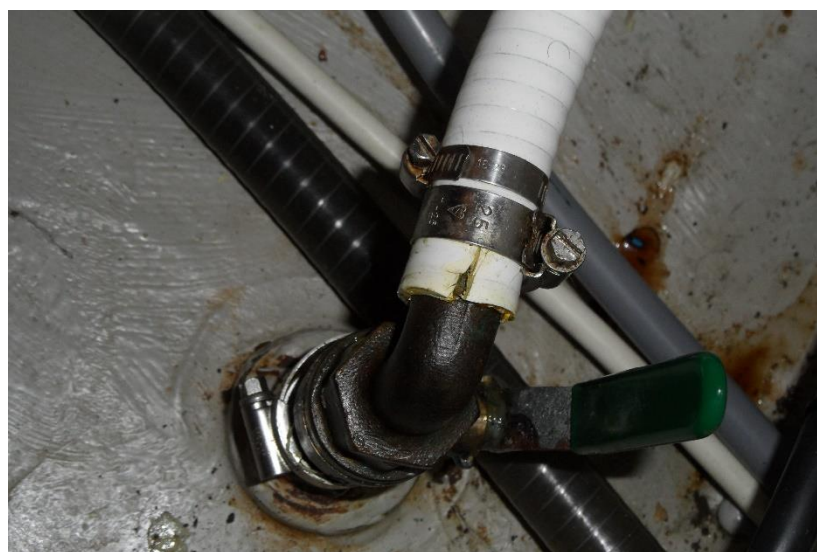
Ref.	Reference	Comment	Description/ Notes
Description		Bronze, DZR brass and plastic through hull fittings.	
13.1	Fitting security, degradation, dezincification, hose security, double clipped below waterline, valve operation	PASS	<p>Satisfactory. There is a split in the aft heads inlet hose at the open end of the hose.</p> <p>Some of the seacocks were quite stiff and would benefit from working open and closed with some lubrication.</p> <p>There is salt crust build up around the ends of some hoses indicating they have been weeping.</p> <p>1)Recommendation – remove, cut away split hose and replace the hose on the aft heads seacock.</p> <p>2)Advisory – monitor the water pipes and seacocks for weeping and tighten the hose clips, as necessary.</p>

FIGURE 1, REFERENCE 13.3 - SPLIT HOSE ON AFT HEADS SEACOCK.

Defect	Recommendation	Action Date
13.1.1	1)Recommendation – remove, cut away split hose and replace the hose on the aft heads seacock.	ASAP.
13.1.2	2)Advisory – monitor the water pipes and seacocks for weeping and tighten the hose clips, as necessary.
