Yacht Manual 'Charlotte Rose' Westerly Riviera 1993

MCA SSR60748
HIN SOU 605890

Charlotte Rose - Westerly Riviera, Fin Keel. Built 1990, commissioned 1993

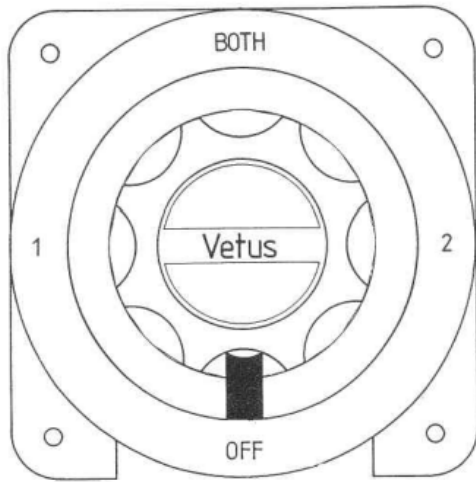
Fig. 3 - Vetus Isolation Switch

Main Battery Isolator;

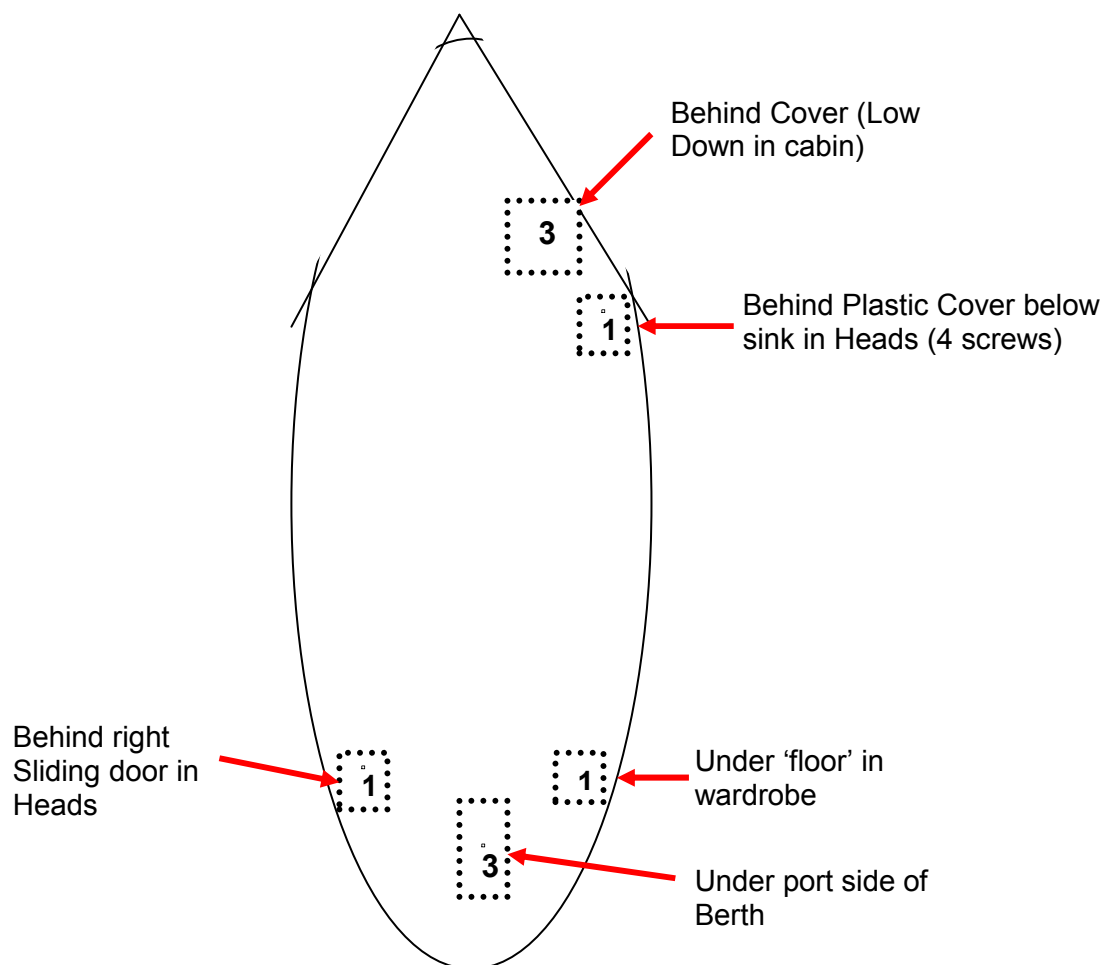
Seacocks Layout Top View (9):

- Three forward cabin below bunk via access hatch
- One Forward heads below the basin behind screwed cover?
- One Rear heads below the basin behind sliding forward door
- One Rear cabin under floor in the main Locker
- Three Rear cabin under port side bunk compartment

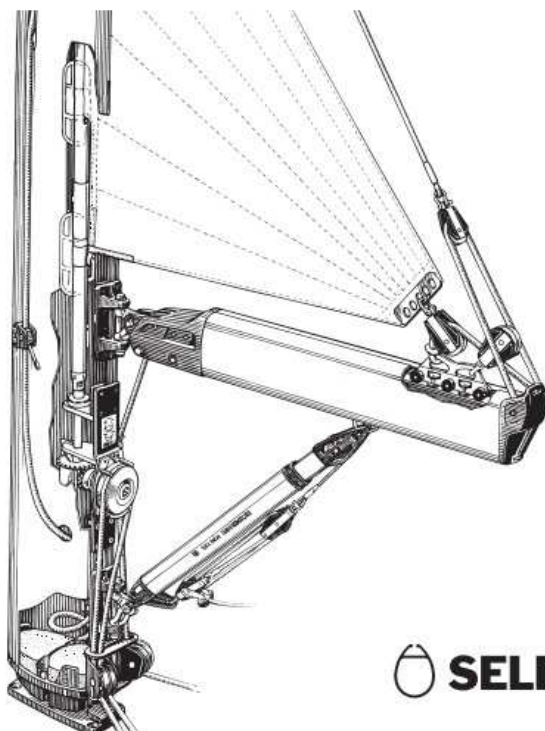
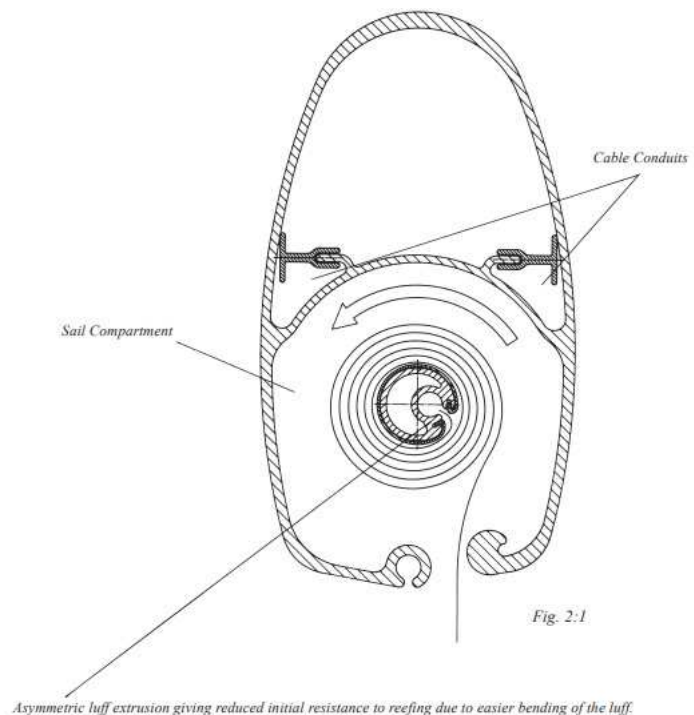
Seldon Main Sail Reefing & Furling

Seldon - Use the ratchet when:

1. You leave the boat to make certain the sail is secured. Remember to take the ratchet off before deploying.
2. If you use a winch handle on the drive to reef the sail
3. If the wind is over 20 knots. This will allow you to reef the sail in but you will not rely on the endless line to stay tight in the driver.

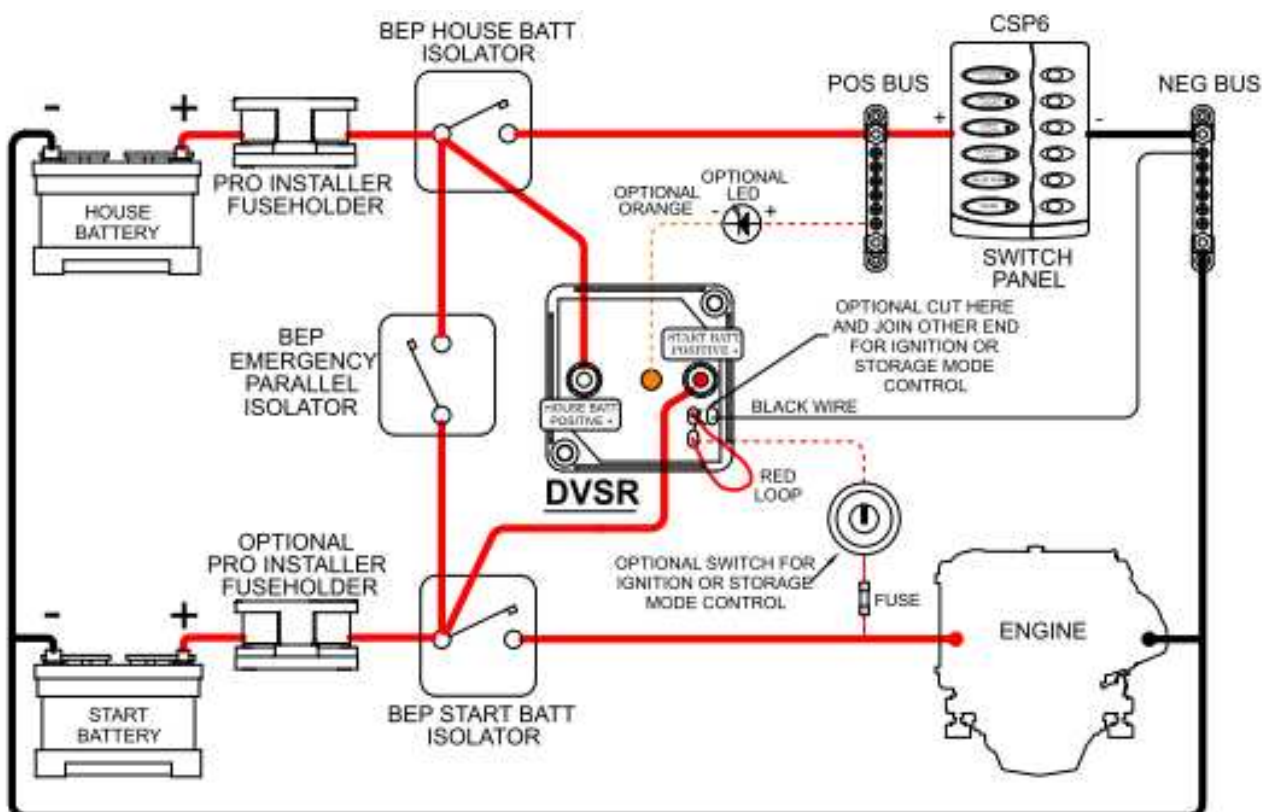
VETUS General approx wiring Diag:

- The Negative charging cable was initially missing! (not installed). New Common/negative (black) cable has been run from forward battery to the main batteries and fused at battery end, tinned wire used.
- The battery charges via a 'BEP' voltage sensitive relay, this connects to the positive end of battery (Yellow marked wire), via a 20A fuse to the BEP unit
- This unit is connected to the positive of battery TWO And negative battery ONE (which is common but this common is only for the RELAY and not the forward vetus battery)
- BEP - Has LED on left (low down) – this lights when relay closed and charging – tested, OK

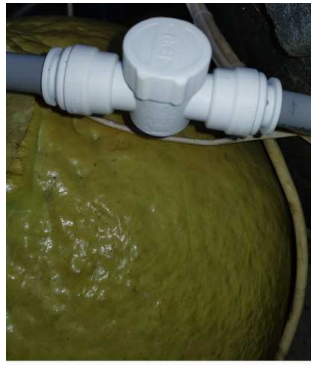
Calorifier & Hot water system

- Works off the main fresh water pump
- There is a large white tap to turn on the water supply / pump, rear starboard side of tank
- There is a water circulation tap (white) near the top of calorifier. This must point forward to turn on the water circulation –this was closed!

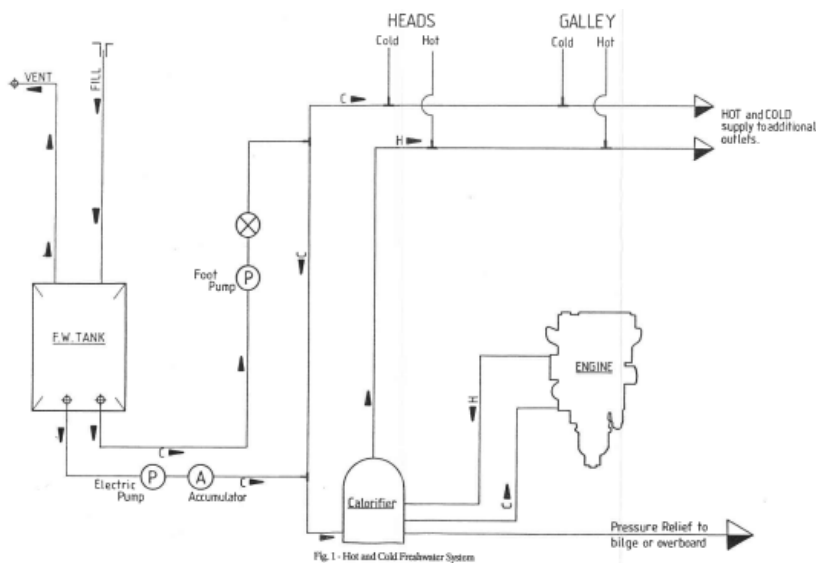
- Has an accumulator – on the port side, forward of the calorifier
- There is a pressure release valve on the calorifier half way down port side.
- Sometimes water gets into the bilges – this could be the expansion water?
- 3kW heater, working tested - The emersion 240V switch is port side of cabin and has a red on light.
- The pump primes the system occasionally, presumably due to expansion / contraction within cylinder
- Pipes go to the accumulator in parallel with the tap, after the pump
- Pipe from top of tank goes via valve / tap to forward cabin under sink unit then splits to the galley and rear cabin taps

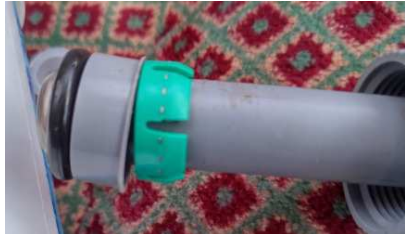
- (Sold by: Boroughbridge Marin £31.99Amazon)
- 15mm Hep2O fittings:
 - <https://www.johnguest.com/gb/en/products/jg-speedfit/fittings/push-fit-plastic-fittings>
 - Screwfix does these JG fittings! Have spares
- New Filter:- Just fits between existing pipes, screws up, but difficult as almost impossible to get both hands into position to push it in and tighten – need cushion behind back to get hands free.
- Fitted into the existing Hep2o fittings,
- Note; the O’ring is **within** the old fittings – you do not need another on the inlet/outlet pipes of the new filter, **ONLY the green fitting** in pic:

-
- When replacing, check O-ring is in the groove of old grey cap

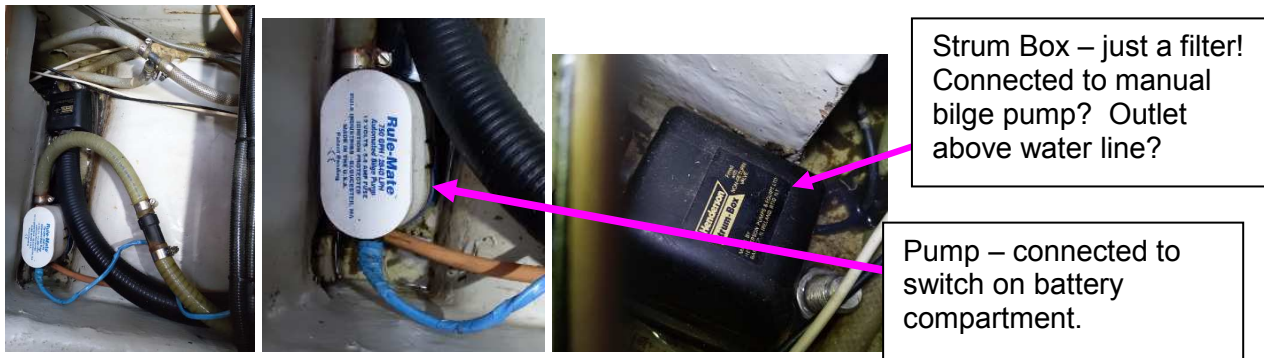
- Mid section under floor next to forward heads door – there are two bilge pumps (see pics)
- There was considerable water in this bilge – is this required so that the pumps can use the water to keep them from running dry?

- Rule-Mate automatic bilge pump, plus Henderson strum box (filter for manual pump). Does one of these do shower basin –no this is under the sink unit behind fitted board

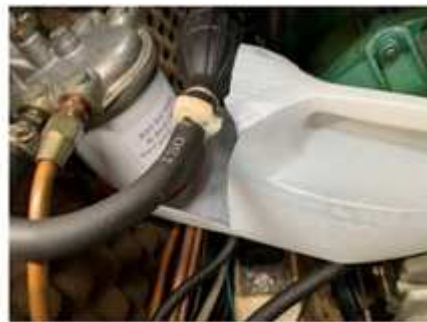
Catching fuel when repacing filter.

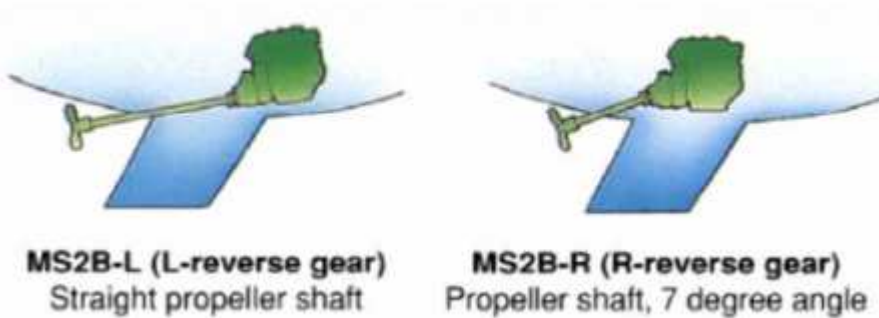
There are four transmission alternatives in the 2000-Series, all with easily-operated cone clutch with an overload protection feature: the R, L, V and S versions. The R-version is angled down at 7 degrees on the output shaft that makes installation easier and saves space. The L-version is straight.

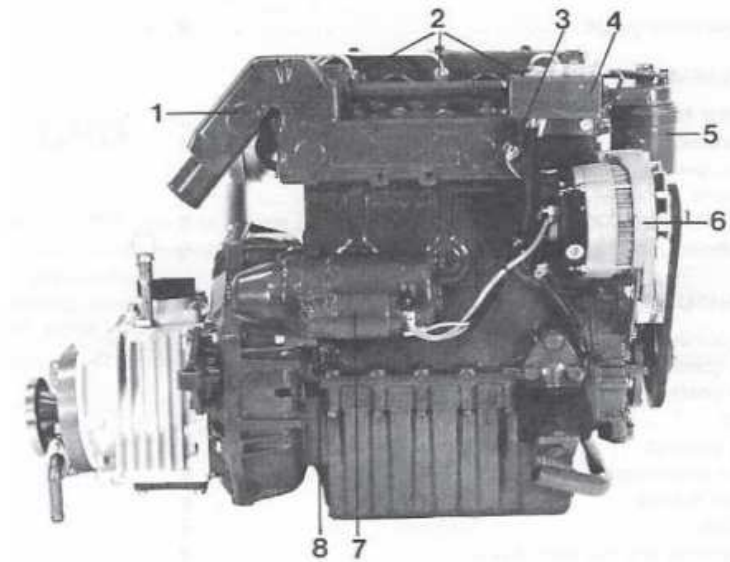
Volvo Penta 2003 Starboard Side Components

1. Exhaust Elbow
2. Injectors
3. Temperature sender
4. Electrical distribution box
5. Fuel filter
6. Alternator
7. Starter motor
8. Drainage, cooling water

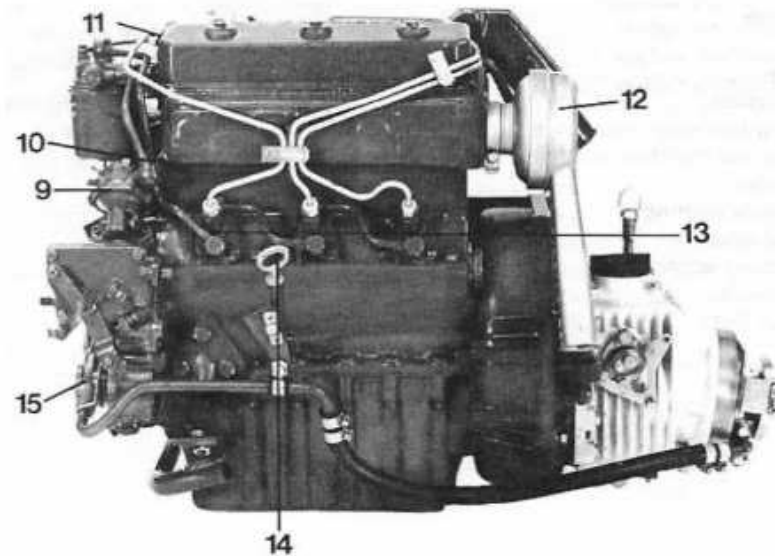
Volvo Penta 2003 Port Side Components

9. Feed-pump
10. Engine serial number
11. Decompression device
12. Inlet air silencer
13. Fuel injection pumps
14. Oil dipstick
15. Sea-water pump

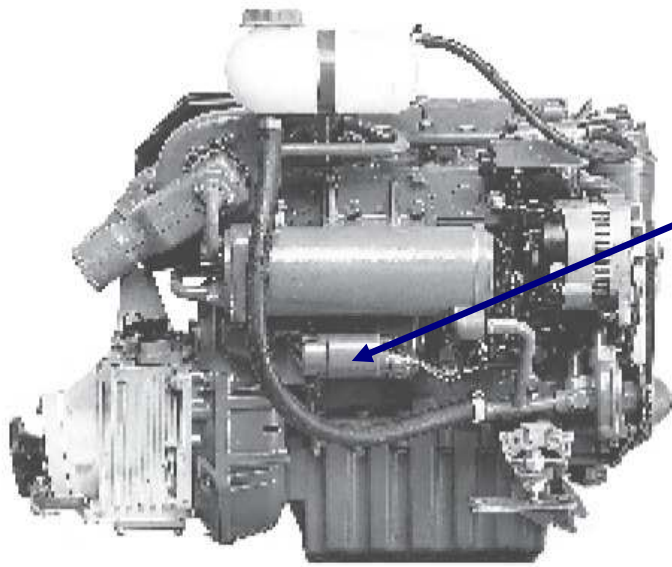
Oil Cooler!!

Check the oil cooler, the bronze and aluminum bits are separated and insulated by the 'O' rings under the end caps if the salt and corrosion bridges the gap the aluminum housing dies and you loose all the oil and will cost a fortune.

They have a brass insert in an aluminium body. The ally body can rot out electrolytically and dump the oil in the bilge. Worth inspecting externally for oil leaks at least annually. I caught mine going last year and replaced it with a used one. A better alternative if I'd had more time would have been to adapt the pipework to accommodate a generic bowman oil cooler - cheaper and better engineered!

If you own a 2003T you must examine the oil cooler carefully and regularly for corrosion. It's hidden under the heat exchanger. Secondly, also check for corrosion of the external steel high pressure oil pipe which feeds the turbocharger. A leak from either of these can dump the entire contents of the sump into the bilge and the first you'll know is when the engine suddenly stops.

- the usual failure is corrosion between the bras and caps and the aluminium body.

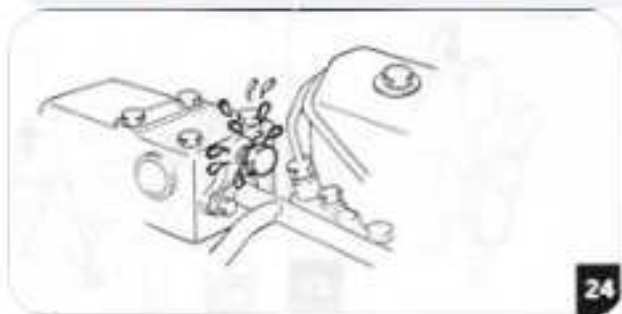
Is it the turbo model 2003T or the non-turbo 2003? If it's the turbo one you **MUST** bleed the air out where it enters the turbo housing (see pic). Also, I'll DM you and send you the owner manual it covers all this stuff.

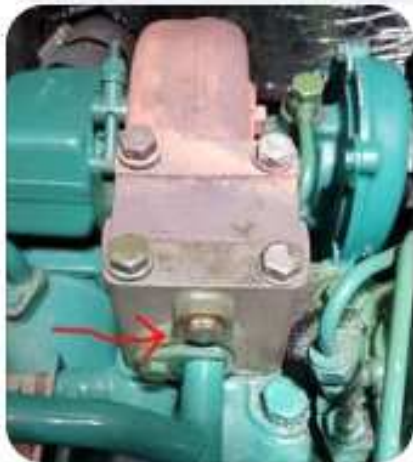
Here's where I bleed the air on my 2003T:

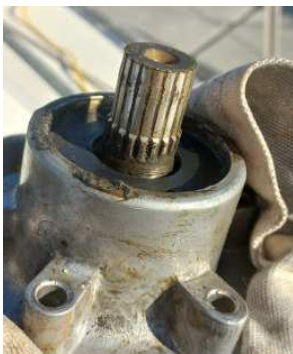
My marine engineer friend was angry when he discovered it, as design is pretty poor. The bronze rotor uses friction alone to fix onto stainless spline. Also, the whole assembly is spring loaded, so any wear means rotor is pushed against front of casing, causing more wear and friction. He's drilled through the rotor, dimpled the stainless spline and put in a grub screw, so that should solve problem temporarily. Also, I've noticed that engine can run in neutral for a long time before overheating, but 2 mins under load will be enough to overheat.

- Access is pretty easy-just need to release pump from bottom left of the block, but catching coolant can be tricky. We just let it all run into bilge and I sponged it all out. If rotor turns freely on its spline, you'll know that's the problem straight away. Also, might be an idea to test the sensor in hot water, just in case that's faulty?

All parts for fresh pump are available, so worst case scenario may cost £250 to replace including rotor itself.

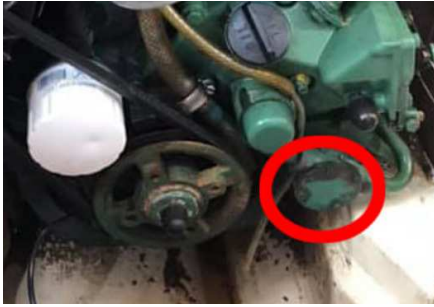
Seawater Pump:

- <https://www.youtube.com/watch?v=J09kaePFEL8>
- Tim Bigden - Douglas Ellison in my experience changing the water side seal is not enough because the shaft gets worn. So new shaft is generally needed.
- Two years ago I replaced the seals then the leak returned. Much better to replace the shaft and seals together. It is not difficult to remove that block. If bolts are rusted replace them. You have two circlips to remove, otherwise quite straightforward. Two hours work last week. Just check the diagram on the xylem website when you order the parts.

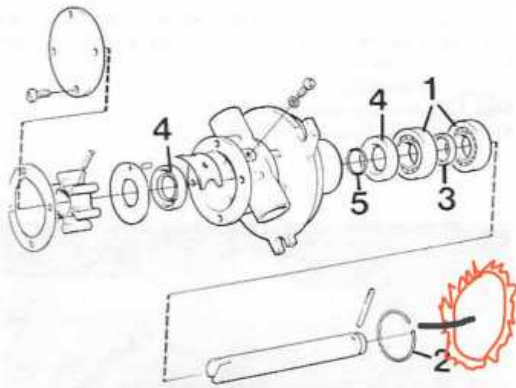
Sea-water pump

27. The pump is equipped with two ball-bearings (1). When disassembling, remove the locking-ring (2) in the housing and push out the shaft, whereby the bearings are following. Use a suitable mandrel to remove the bearings from the shaft. NOTE! Do not forget the spacer sleeve (3). Replace the sealings (4). NOTE! Turn the sealings correctly and make sure that they do not block the drainage hole in the pump-housing. Replace the O-ring (5). Install the ball-bearings and the spacer sleeve onto the shaft and leave a distance of 39,5 mm (1.55512 in.) from the shaft end to the ball-bearing. Coat the shaft with grease and "screw" it through the sealings and the O-ring and take care not to damage them. Push in the shaft as far as to allow the

ball-bearing. Coat the shaft with grease and "screw" it through the sealings and the O-ring and take care not to damage them. Push in the shaft as far as to allow the bearings to bottom and then install the locking-ring (2).

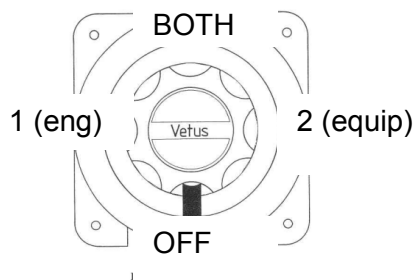
Battery Isolator / Selector – Port side of cabin steps (low down)

- Battery Main Switch (KEY) for Anchor Windlass – to rear of Main Battery Isolator
- Bow thruster MAIN switch in forward cabin low down port side, Vertically down = 'ON'
- General instruments and navigation manuals on top of cabin forward port locker
- Maritime lights and info on hook rear bulkhead of main cabin
- On push to turn on each Navigation plotter (Internal & External helms), press and hold to turn off
- Onwa Internal Navigation Plotter has AIS ship identification (can set alarms, turn off in port)
- LOG – (Display not working), Use either plotter SOG (top of display)
- Autopilot – cockpit starboard side rear, push 'on' once, then 'Auto' when correct heading, Engage Steering Helm Gear Port side of Wheel
